PAPER GOODS POND DAM

CT 00253

PHASE 1 INSPECTION REPORT
NATIONAL DAM INSPECTION PROGRAM

MARCH, 1981

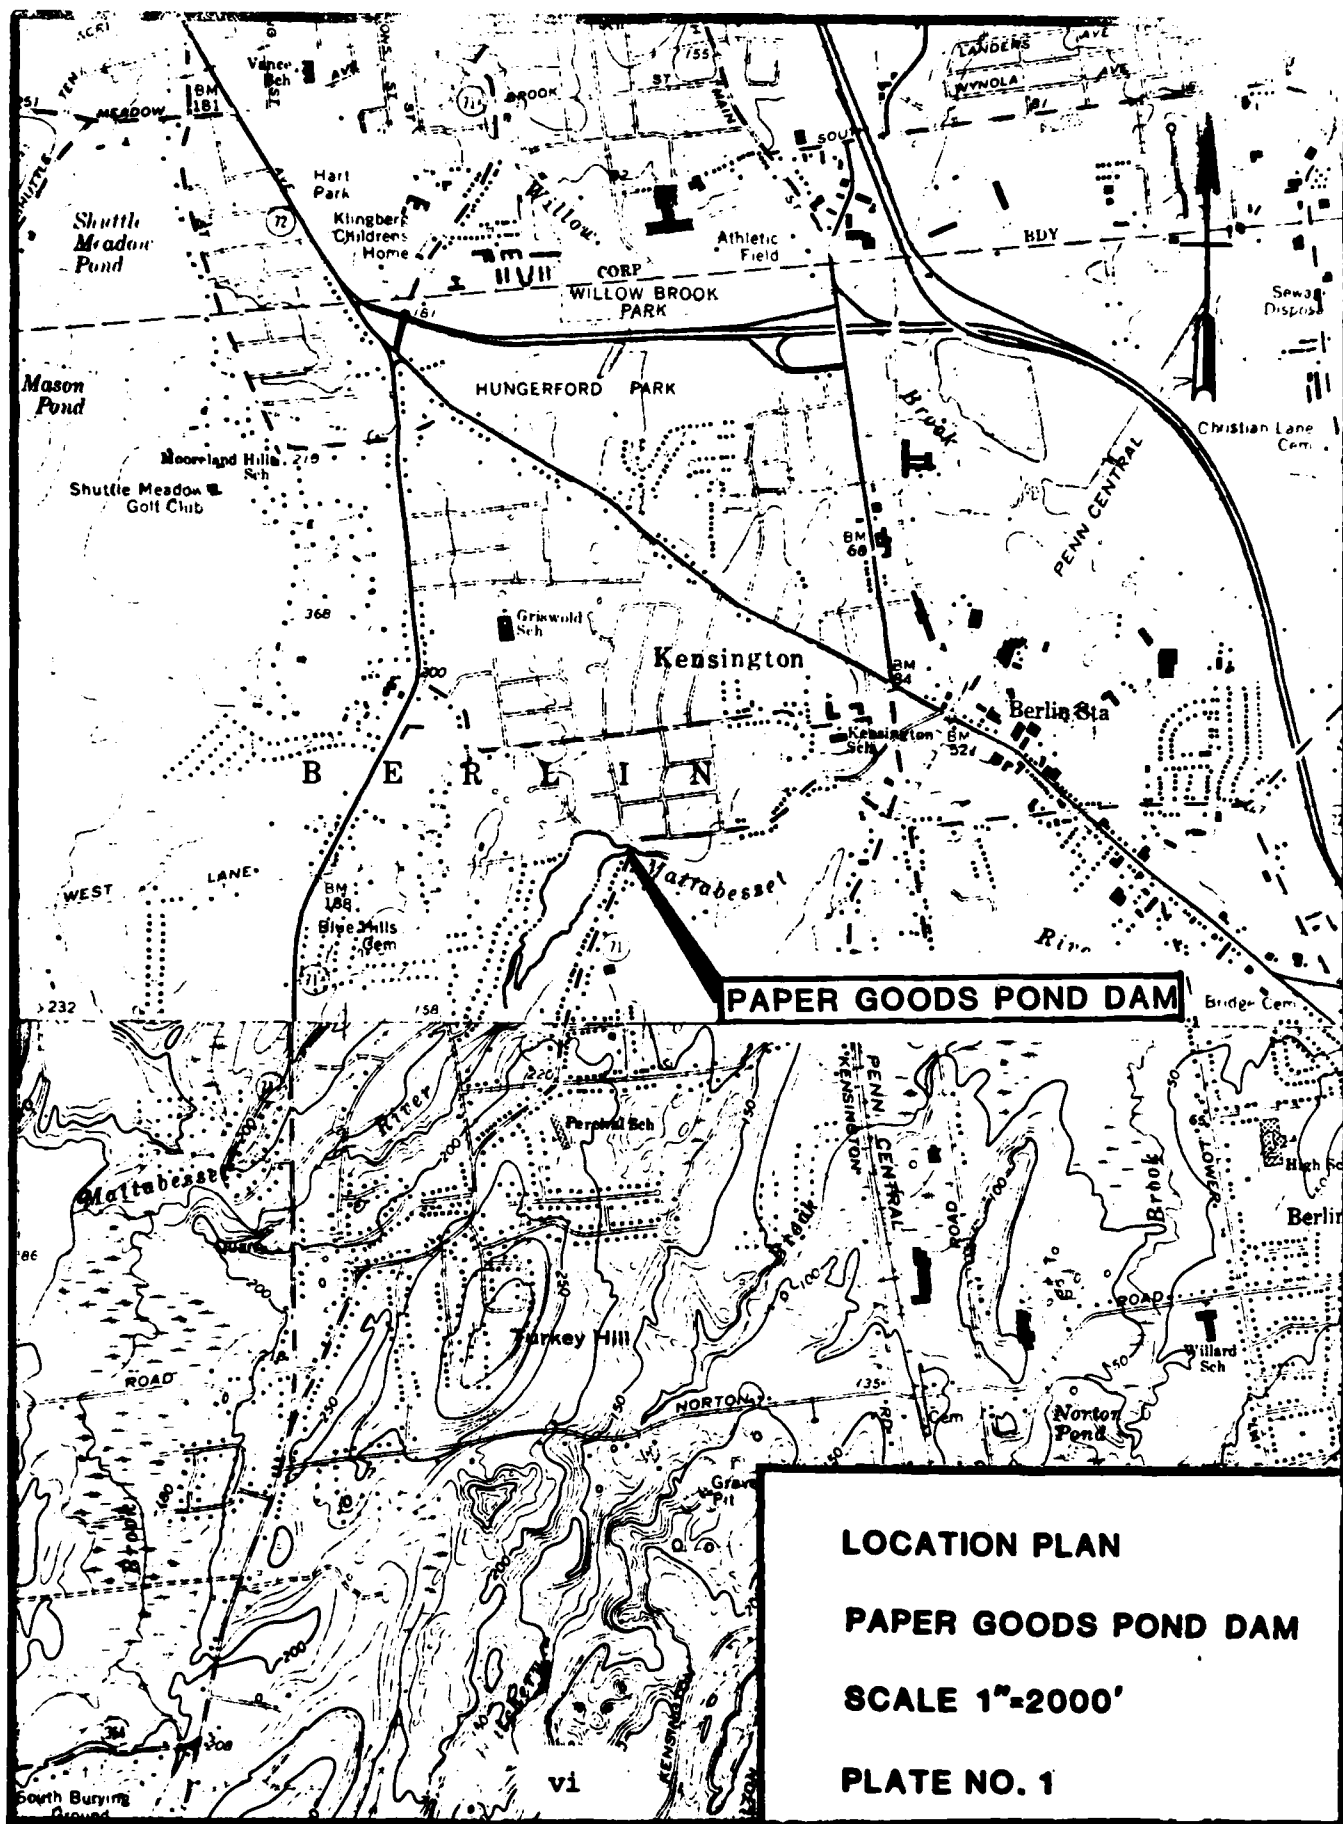
OVERVIEW PHOTO - PAPER GOODS POND DAM

Based on visual inspection and past operational performance, the dam is judged to be in FAIR condition. Seepage was noted through the southwest abutment and along the southern downstream channel wall. The 10 inch supply main presently has no control at the dam.

The following remedial measures should be taken by the owner: Clearing the downstream channel, repair washouts of stone walls along downstream channel, supplementing the existing emergency plan with a downstream warning plan and an annual technical inspection program.
